# Potential induced degradation (PID): a test campaign at module level

**Abstract** – Potential induced degradation (PID) of photovoltaic (PV) modules gets a lot of attention since 2010 when Solon published their findings about a degradation mechanism in their PV modules caused by high potential differences. [1] When multiple PV modules are connected in series, a potential difference up to 1000 V or at some places even 1500 V is created between the cell and the grounded frame. This electrical field causes a leakage current and ion diffusion. PID is a multi-level degradation with causes and solutions at cell, module and system level.

A test campaign was conducted within the frame of a feasibility study for pidbull, a curing technology for PID developed by pidbull nv. 80 PV modules were characterized whereof 49 PV modules were stressed and cured for PID. The selected set of PV modules was composed of 49 different module types of 33 brands. The test was done according to the foil-method, as described by the standard in progress IEC 62804. However, to apply higher stressing and curing rates, the modules were tested with an aluminium foil inside a climate chamber for 96 hours.

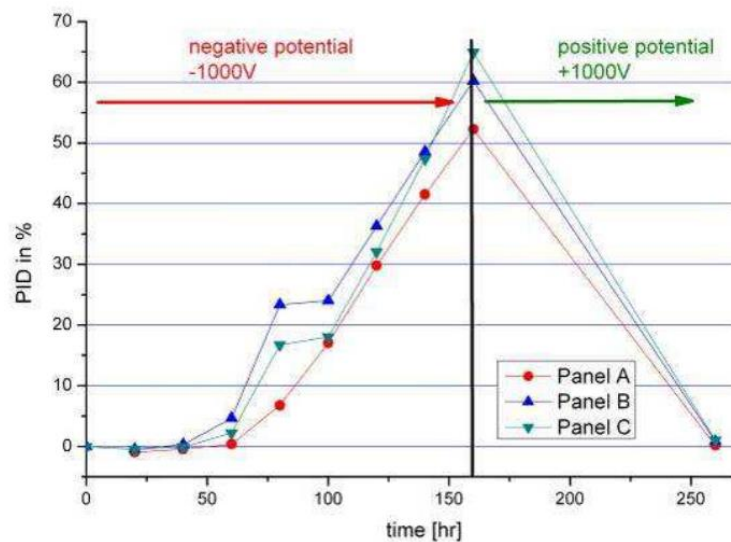
Figure 3: PID and recovery by reverse potential. [1]

In the paper by Pingel *et al.* [1] a similar degradation caused by HVS was described on p-type standard cells. Besides the precondition of having a PID sensitive cell they also showed ways to stop or minimize PID on panel and system level. According to them, PID depends on polarity and the level of the potential between the cell and ground. On panel level they describe the leakage currents in a lab PID setup as shown in Figure 2. As was already described, they also mention the possibility to recover the lost power by applying reverse potentials as shown in Figure 3.

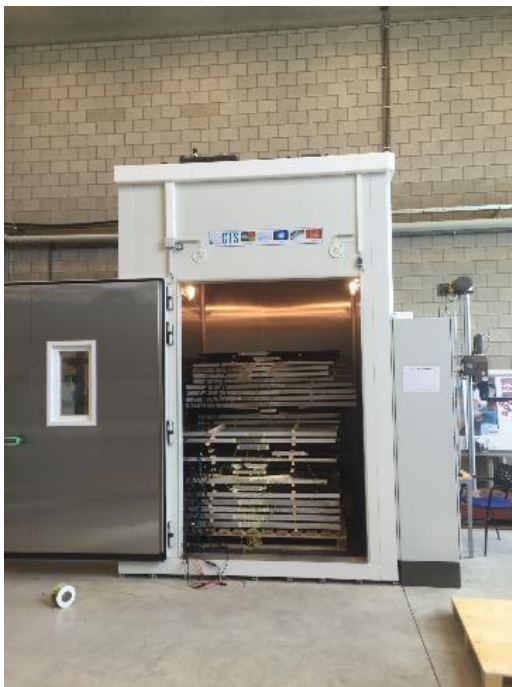
Figure 5: The climate chamber with the PV modules stacked for the PID stress test.

In order to apply a higher stress level to the modules, the proposed tests were combined; the modules were covered with an aluminium foil and stressed for 96 hours inside a climate chamber (a CTS, CW-40/19) at  $60\text{ }^{\circ}\text{C} \pm 2\text{ }^{\circ}\text{C}$  and  $60\text{ \%RH} \pm 5\text{ \%RH}$ . This setup is shown in Figure 5. A voltage difference of 1000 V between the cells, from which the negative and the positive output were short circuited, and an aluminium foil was provided by an Ultravoltage BT-GP-1P30 voltage source. Figure 6 shows the aluminium foil covering the front surface of the modules.

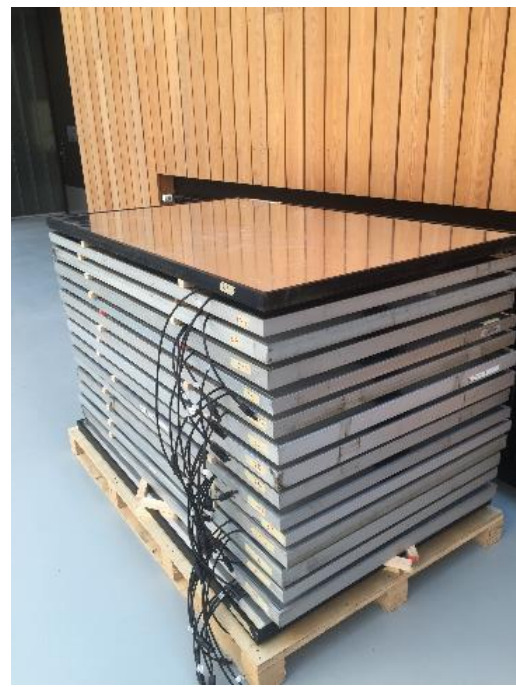
Figure 6: Some of the PV modules prepared with an aluminium foil
